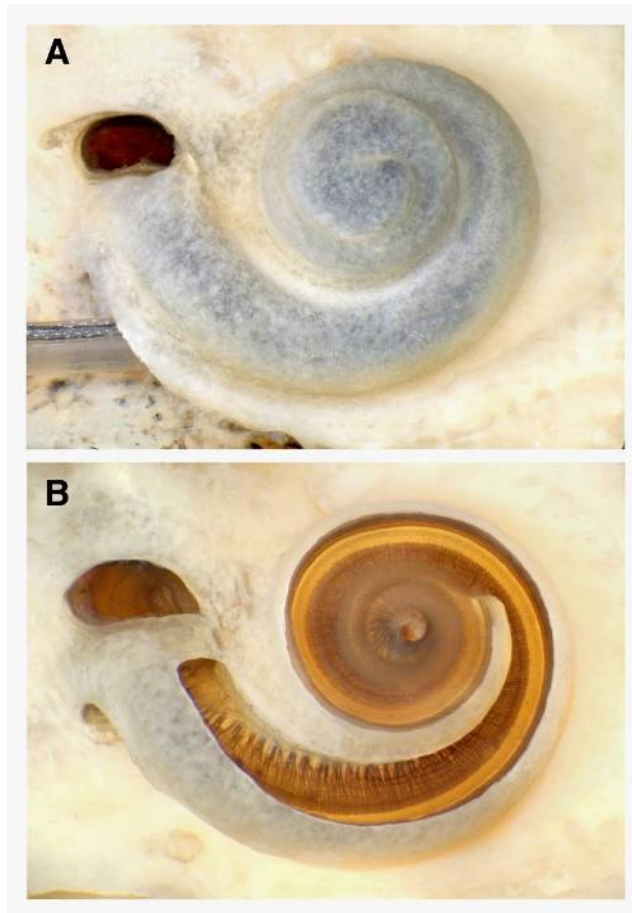
**A:** Otic capsule bone drilled to a thin shell to reveal contours of the cochlea. The membranous labyrinth has been stained with osmium so that it appears dark through the thinned bone. An implant electrode array had been inserted into this specimen and a portion of the array can be seen at lower left.

**B:** Similar preparation in which the bone overlying scala vestibuli has been removed to show the osmium-stained basilar membrane and osseous spiral lamina.

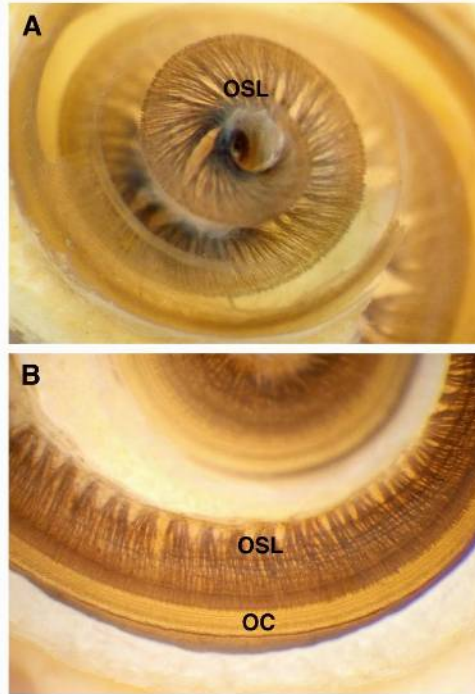
**A:** Apical cochlear turn showing myelinated nerve fibers within the osseous spiral lamina (OSL).

**B:** Basal turn. The organ of Corti (OC) is seen as a lightly-stained band lying adjacent to the osseous lamina.

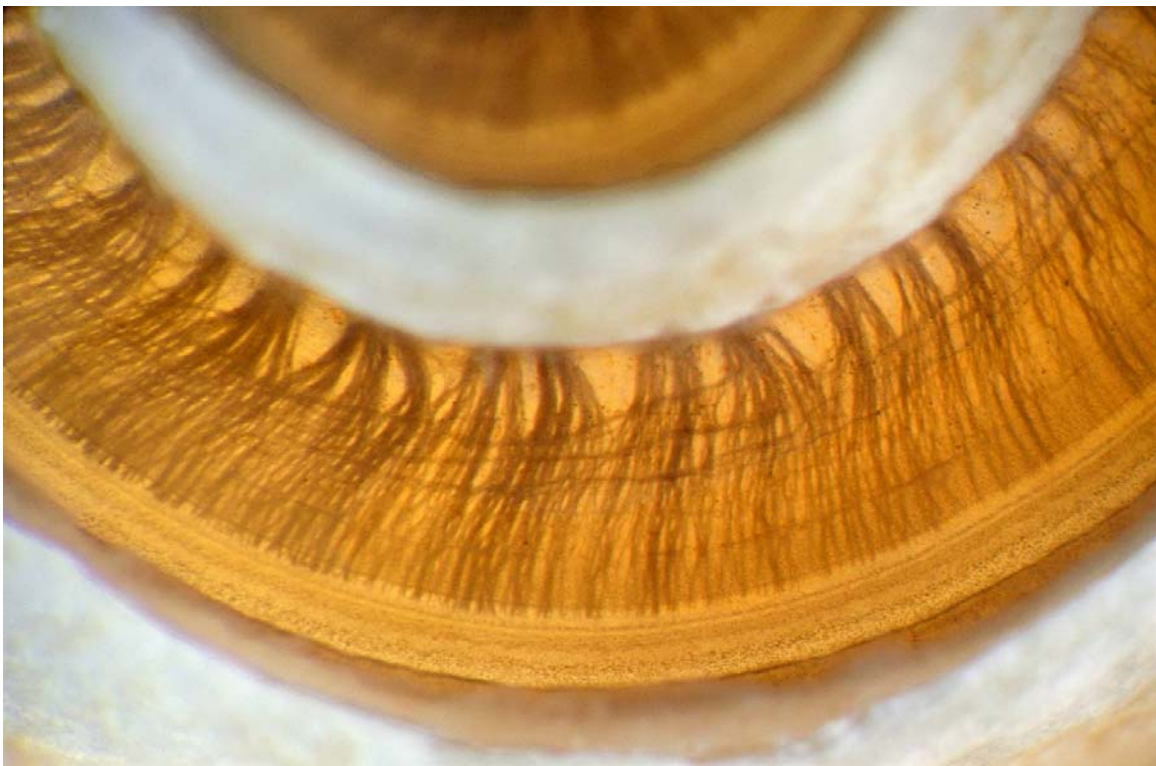
Higher power view of osseous lamina and basilar membrane/organ of Corti in a preparation from an elderly individual in which there has been mild thinning of the myelinated nerve fibers within the osseous lamina. The spirally oriented nerve fibers in the osseous lamina are nicely displayed in this specimen.

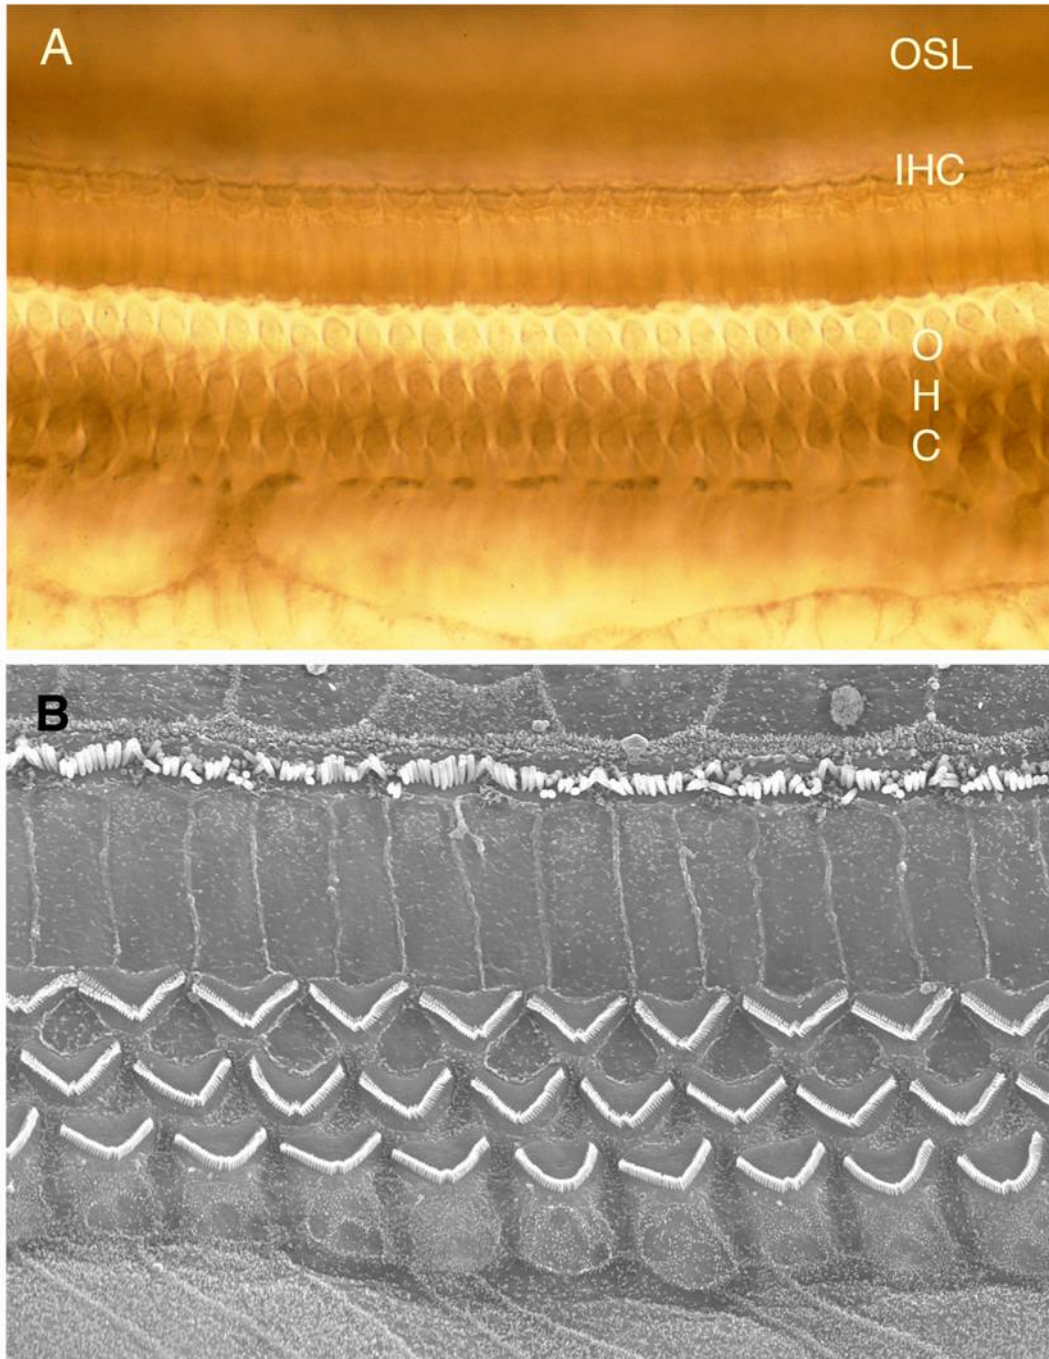
Whole-mount, osmium-stained preparations of organ of Corti as seen by light **(A)** and scanning electron **(B)** microscopy. The level of focus in "A" is such that the cell bodies (rather than apical surfaces) of the outer hair cells (OHC) are seen. These preparations are from laboratory animals.

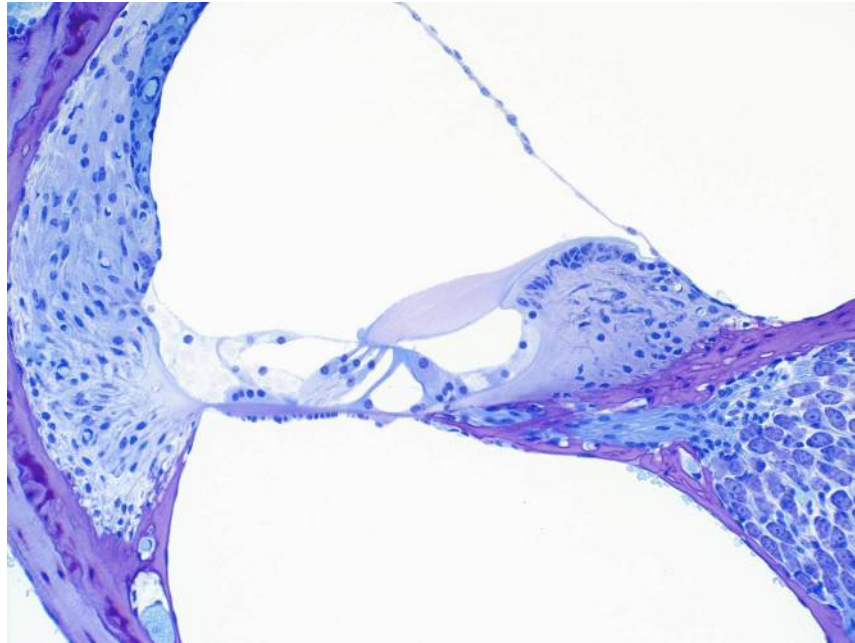
Cross section of mouse cochlear duct, basal turn, showing internal structure of organ of Corti to complement surface views seen in the previous images.

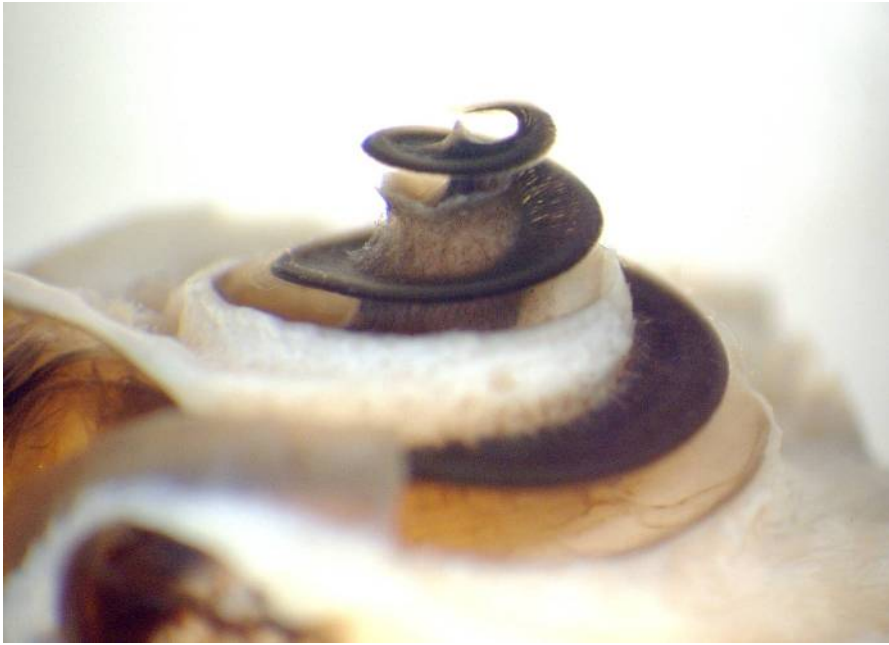
A preparation in which the modiolus and osseous lamina are seen in profile after removal of the otic capsule bone covering the human cochlea.

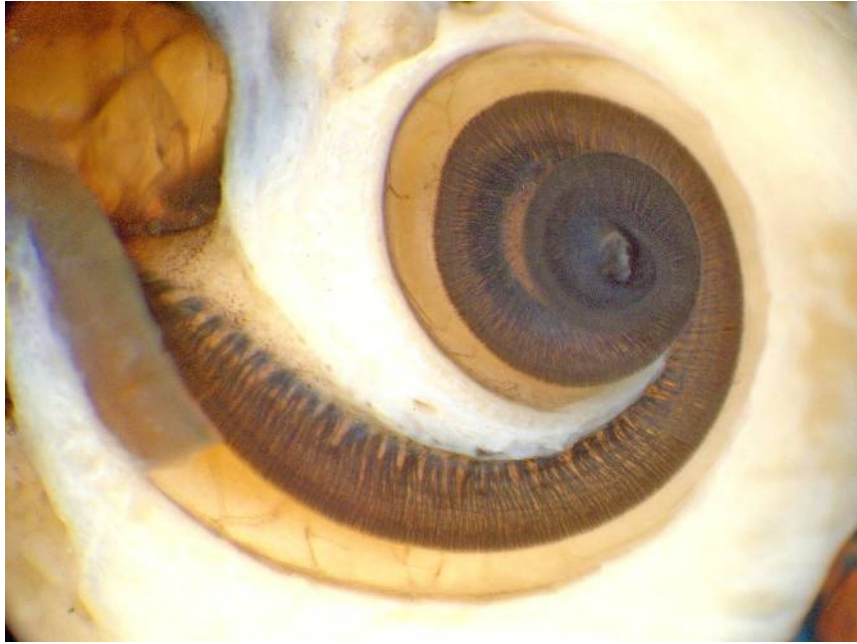
Osseous lamina with its nerve fibers in a specimen oriented in nearly horizontal plane.

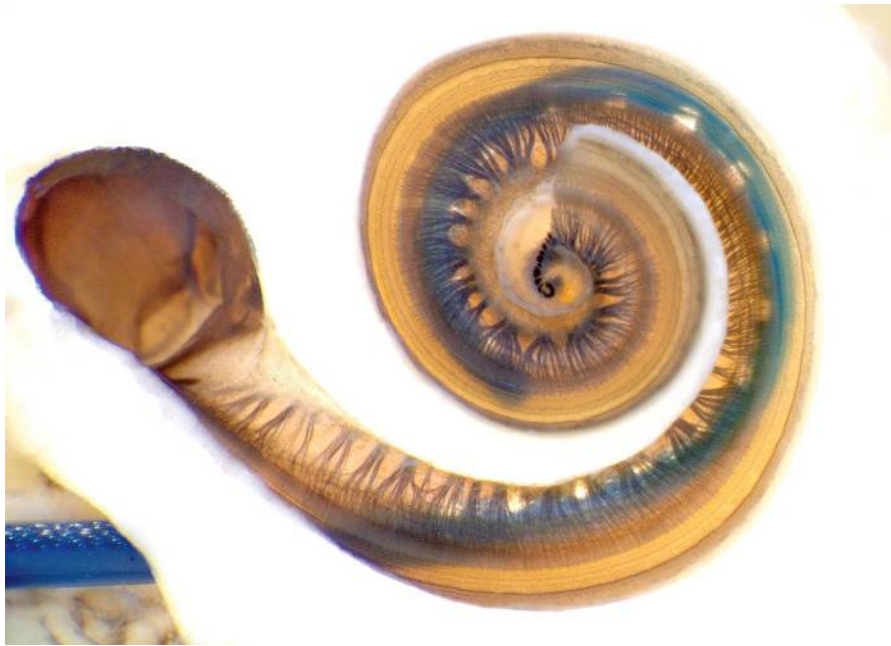
Cochlear dissection after insertion of a cochlear implant electrode array (Advanced Bionics Thin Helix). The array has been colored blue to provide better contrast of the silicon carrier. The array lies in scala tympani and is situated beneath the translucent basilar membrane. The apical cochlear turn has been removed to provide an unobstructed view of the basal turn.

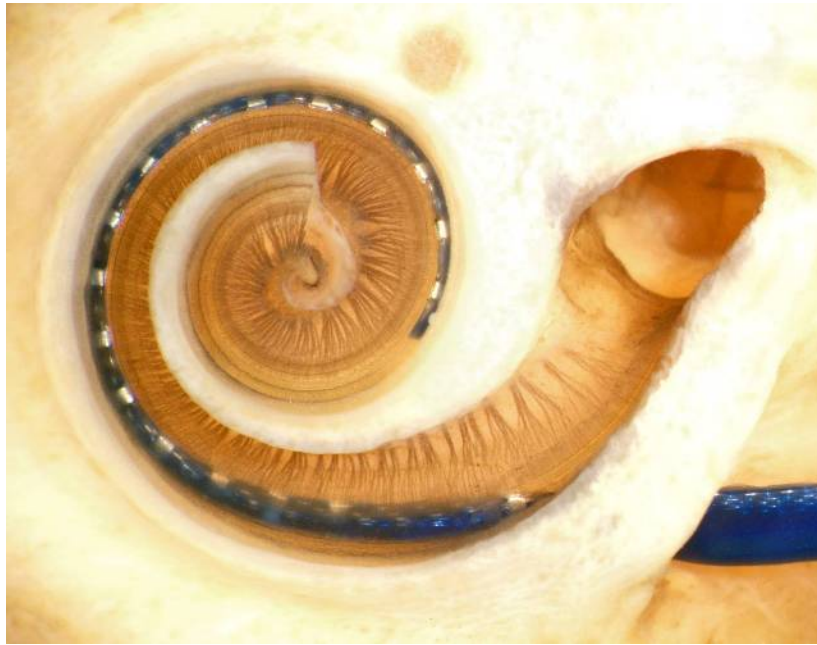
Cochlear dissection after insertion of an Advanced Bionics Thin Lateral electrode array designed to track the lateral wall of scala tympani. With this array, contacts are placed immediately beneath the basilar membrane.

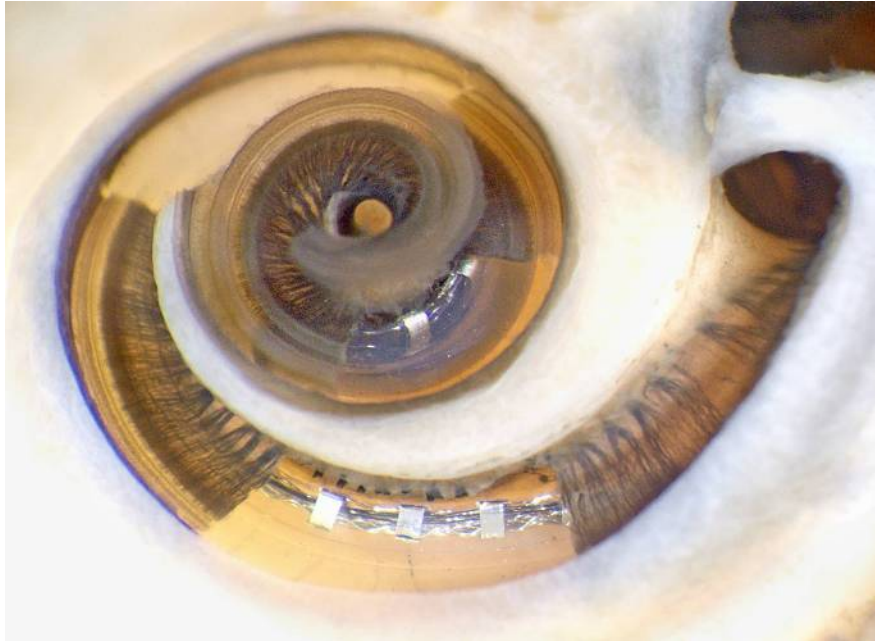
Cochlear dissection after insertion of a perimodiolar type electrode array (Advanced Bionics standard Helix). Segments of the osseous lamina and basilar membrane have been removed to more clearly show the array in scala tympani. The apical portion of the silicone carrier is darkened due to osmium staining.

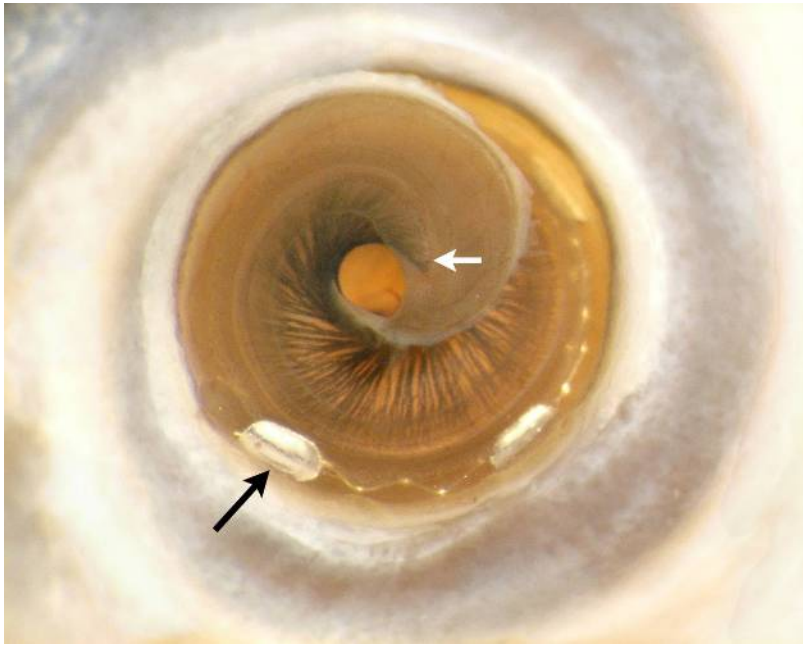
Apical cochlear turn showing a Med-El electrode array inserted to near the apical tip of the basilar membrane (white arrow). The black arrow indicates the apical-most electrode contact which is situated beneath the semi-transparent basilar membrane.

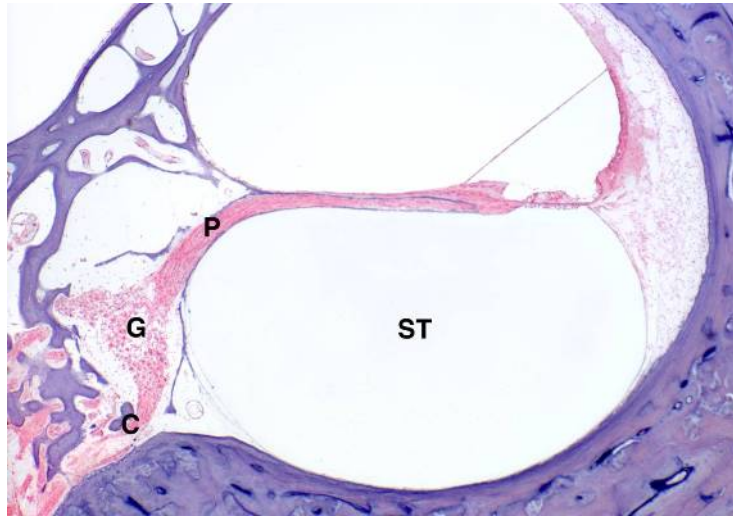
Cochlear cross section showing the spiral ganglion (**G**) with peripheral (**P**) and central (**C**) processes projecting from the ganglion to enter the osseous lamina and modiulus. Note the very thin bone overlying the spiral ganglion and under surface of the osseous lamina.

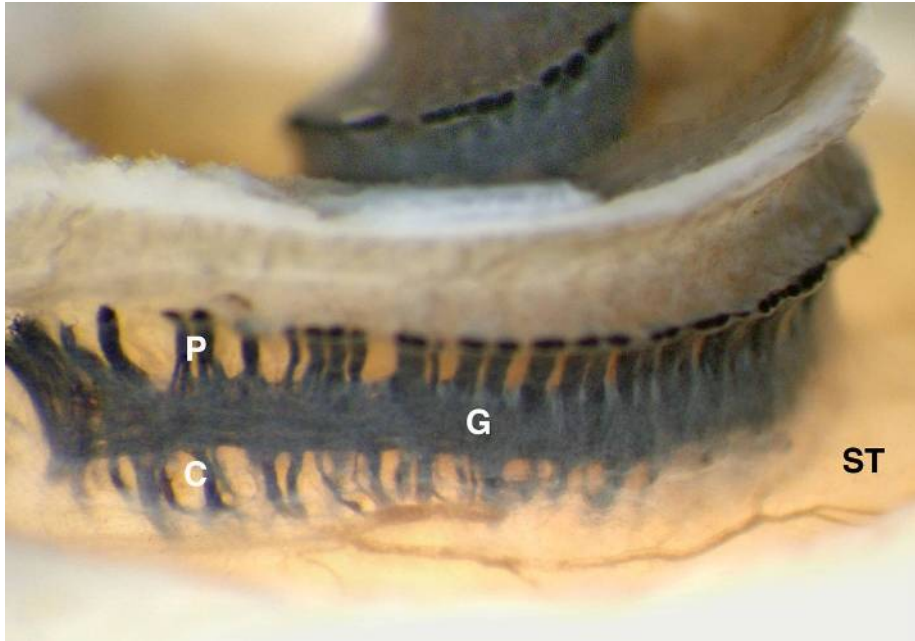
Dissection in which the osseous lamina and basilar membrane have been removed so as to show the modiolar wall in the basal cochlear turn of an osmium-stained specimen. Neural elements associated with the modiolar wall are well displayed. "G" indicates the spiral ganglion. Peripheral (P) and central (C) processes of spiral ganglion cells are seen emerging from the ganglion along the length of the basal turn. ST, floor of scala tympani. This preparation shows the same anatomical features shown in slide 12 from the perspective of microdissection. The specimen received light decalcification, but no bone was removed from the modiolar wall.

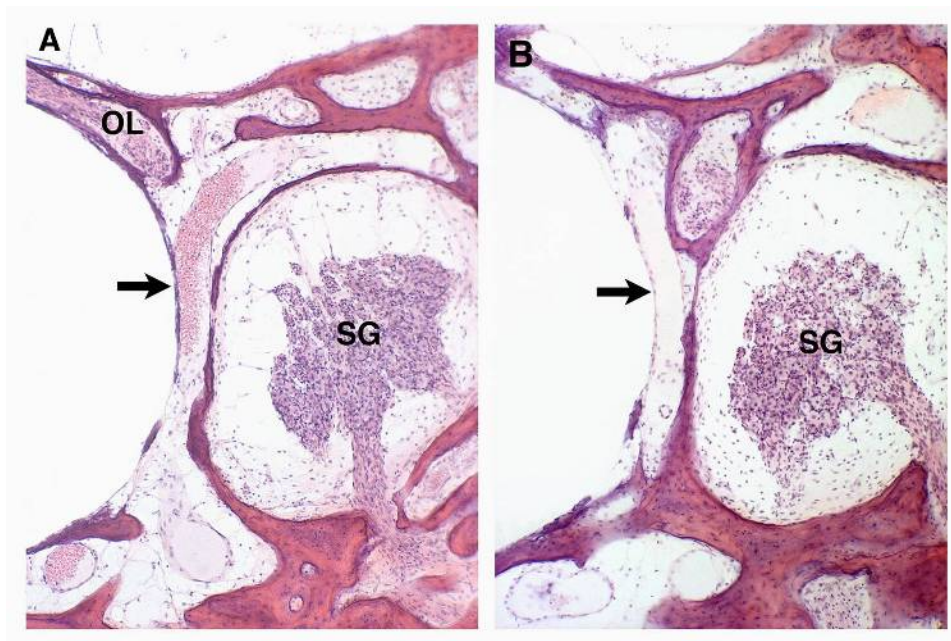
Cross sections of the modiolus region showing veins coursing near the surface of the modiolar wall. In "A" the vein indicated by the arrow has a very thin covering of bone. In an adjacent section, shown in "B" , a similar vein (arrow) appears entirely exposed to the perilymphatic space. (In this case the vein does not contain RBC's, but it certainly does appear to be a vein .) It would seem that such vessels might easily be injured by a perimodiolar electrode. OL, osseous lamina; SG, spiral ganglion. See slide 23 for a view of this anatomy in a dissection.

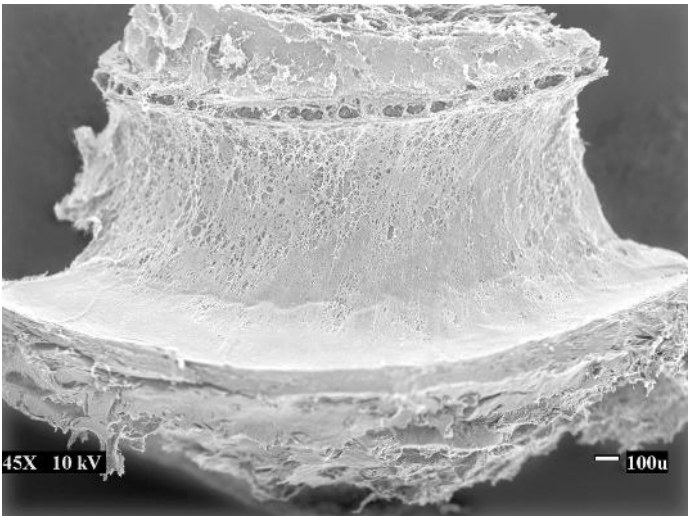
Scanning electron micrograph of the modiolar wall in the basal cochlear turn.

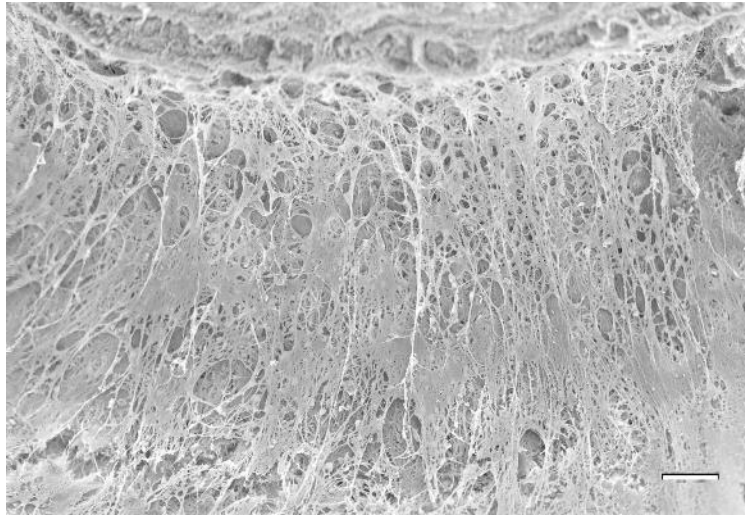
Higher power SEM view of modiolar wall.

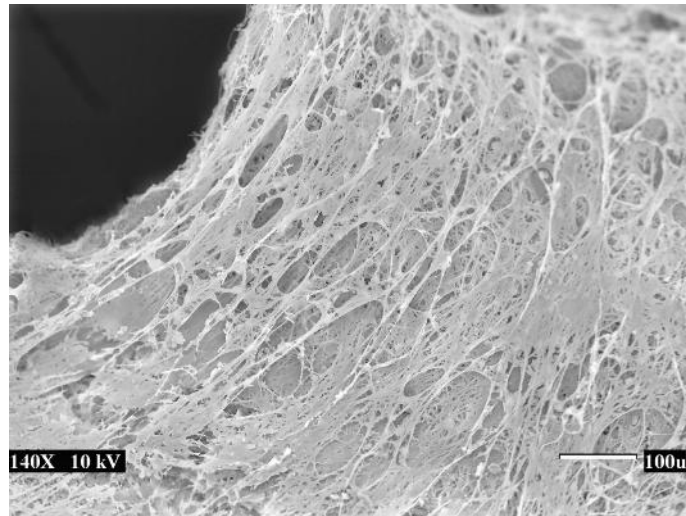
Highly textured surface of modiolar wall seen in profile.

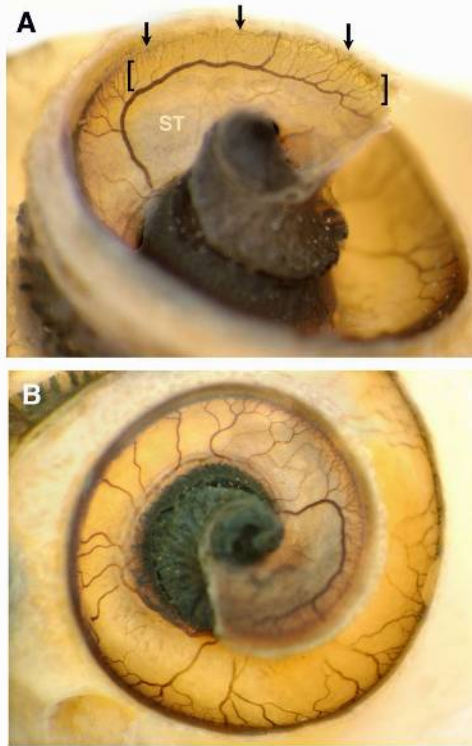
Overview of veins in scala tympani. In this dissection, the osseous lamina and basilar membrane have been removed to provide a direct view into scala tympani (ST). The apical portion of the cochlea is shown in "A". "B" shows the middle and upper basal turns. The arrows in "A" indicate the attachment zone of the basilar membrane and the brackets indicate the approximate area of the lower portion of the spiral ligament which contains the venules that drain the lateral wall tissues.

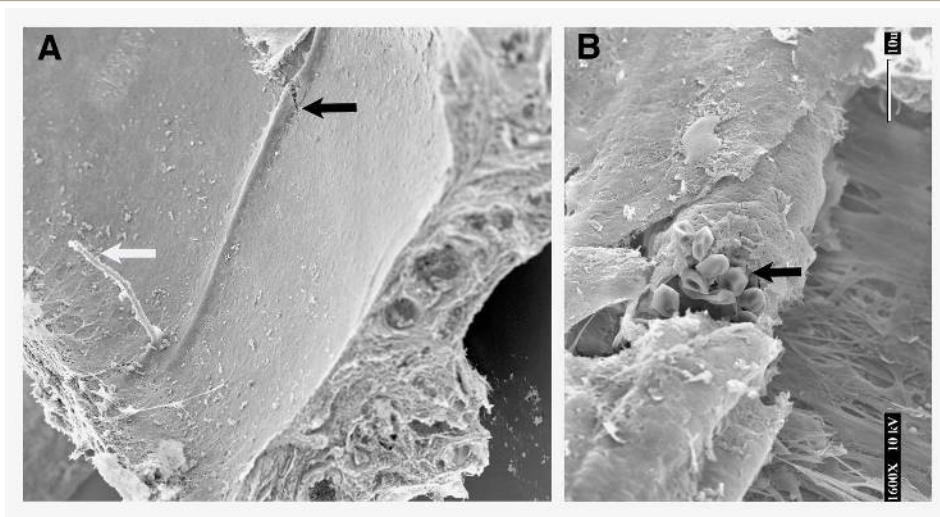
**A:** The black arrow indicates a vein on the floor of scala tympani as seen by SEM. A small vessel crossing the perilymphatic space is indicated by the white arrow.

**B:** Higher power view of the area indicated by the black arrow in "A". Here there is a crack in the tissue revealing RBC's inside the vein (arrow).

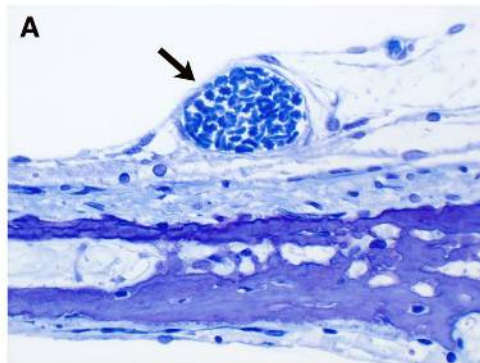
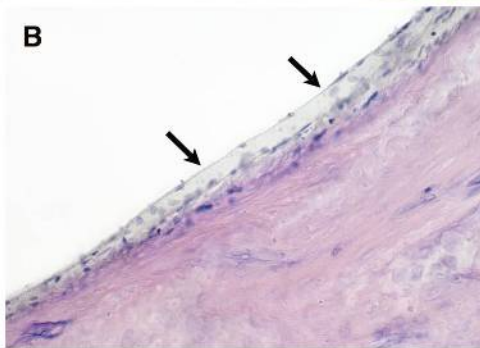
**A:** Cross section of a vein (arrow) on the floor of scala tympani. Note that it has only a thin connective tissue covering.

**B:** Longitudinal section of a vein (arrows) on floor of scala tympani. The vessel appears completely exposed to the perilymphatic space.

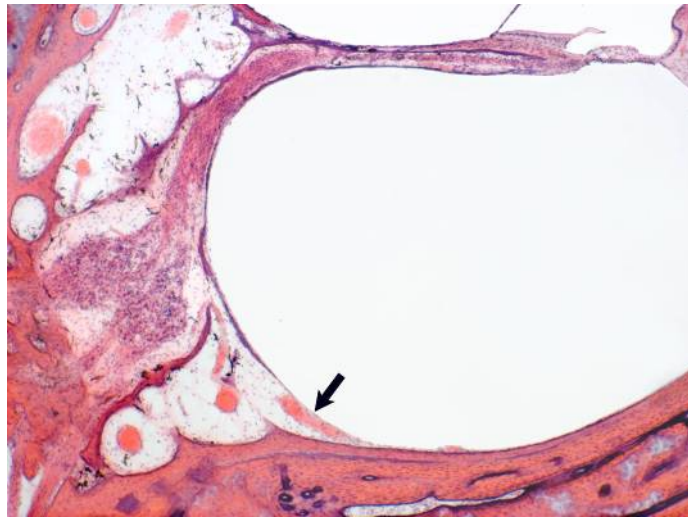
Cochlear cross section showing a vein (arrow) traversing the floor of scala tympani and approaching the posterior spiral vein. The vein has no bony covering.

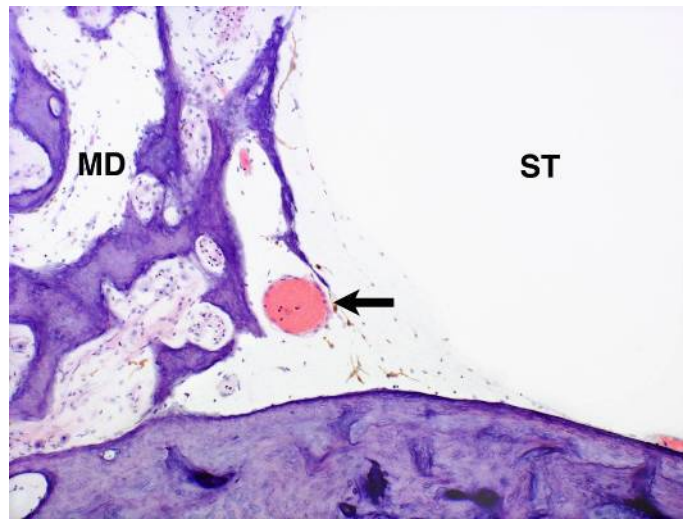
Cross section of the posterior spiral vein (arrow) in the basal turn. In this location the vein has virtually no bony covering. ST, scala tympani; MD modiolus.

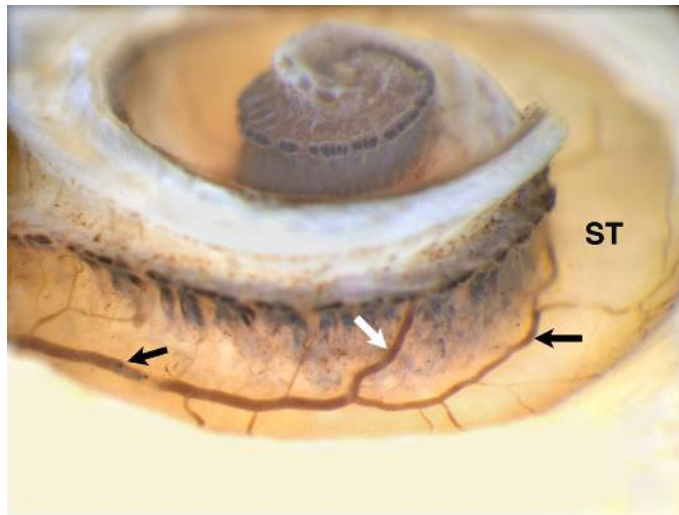
Dissection view of scala tympani and modiolum in the basal turn showing the posterior spiral vein (black arrows). A vein (white arrow) on the side of the modiolum joins the posterior spiral vein. Compare this image with the modiolar cross sections seen in slide 14. This preparation received light decalcification but no bone was removed from the modiolar wall. ST, floor of scala tympani.

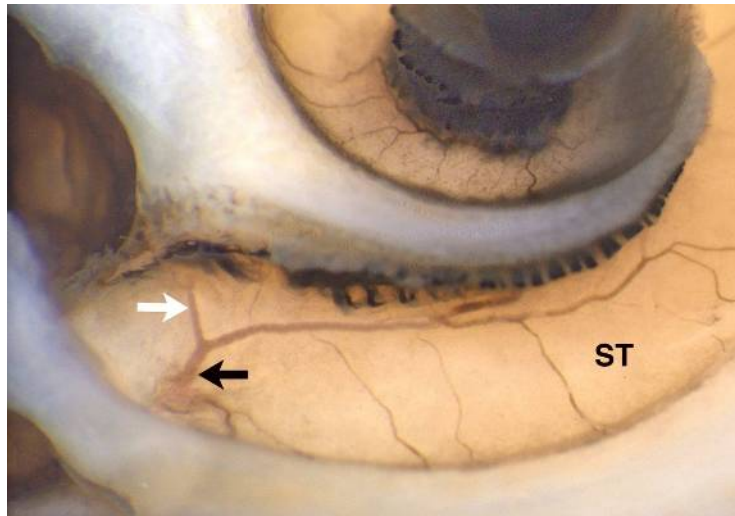
Lower basal cochlear turn showing the common modiolar vein as it enters the cochlear aqueduct (arrow). The white arrow indicates the vestibulocochlear vein which joins the common modiolar vein. ST, floor of scala tympani.

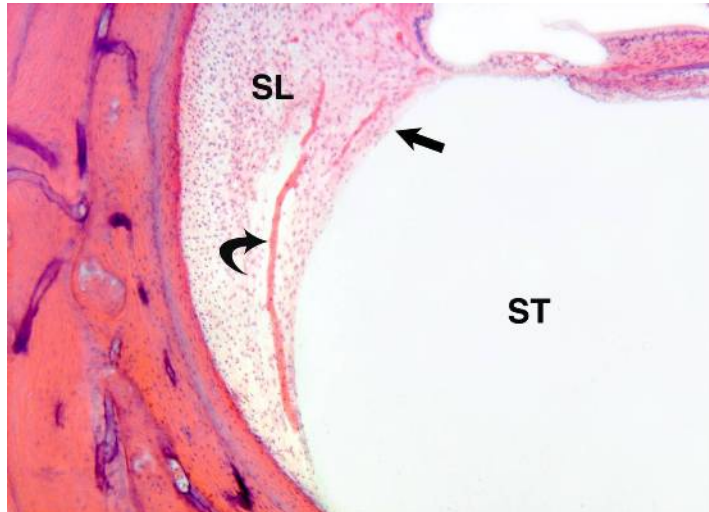
Cochlear cross section showing the lower portion of the spiral ligament (SL) facing scala tympani (ST). The curved arrow indicates a venule coursing through the spiral ligament toward the floor of scala tympani. The straight arrow indicates the portion of the spiral ligament seen in the next image.

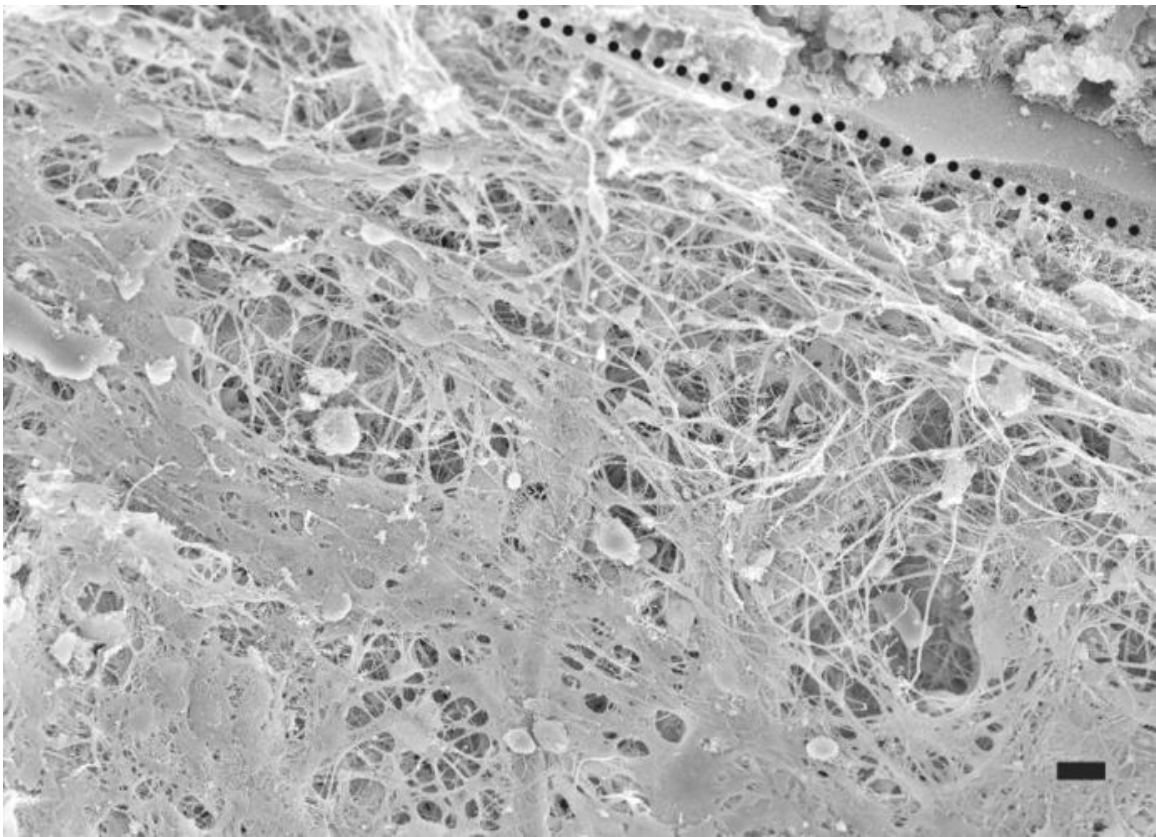
Scanning electron microscopic view of the surface of the spiral ligament in the area immediately below the attachment of the basilar membrane. (The site of attachment of the basilar membrane to the lateral wall tissues is indicated by the dotted line.) Note the highly porous, mesh-like structure of the spiral ligament surface.

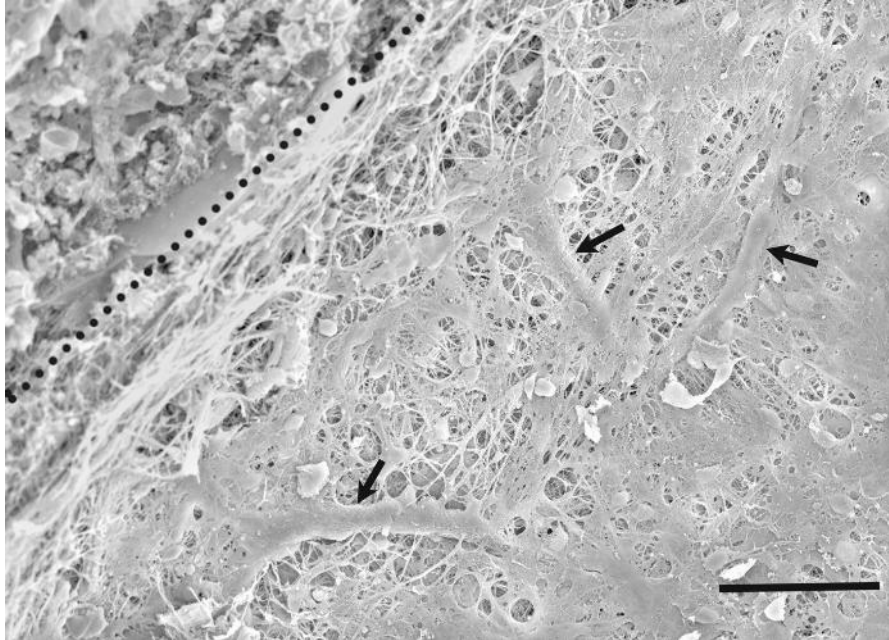
Scanning electron micrograph of the spiral ligament beneath the attachment of the basilar membrane to the lateral cochlear wall (the attachment zone of the basilar membrane is indicated by the dotted line at upper left). As in Figure 26, note the porous, mesh-like texture of the spiral ligament. In the region shown here three blood vessels (arrows) are seen coursing very near the surface of the spiral ligament.

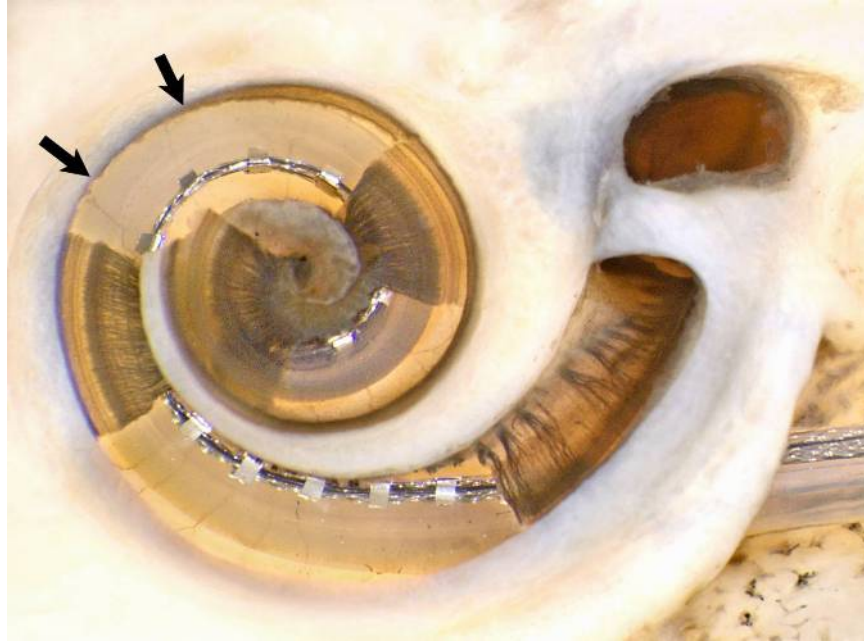
Cochlear dissection after insertion of an implant electrode array. Portions of the osseous lamina and basilar membrane have been removed to more clearly show the electrode lying in scala tympani. The silicone carrier of the array has been lightly stained with osmium so that it has a light brown color. Note that in the area indicated by the arrows the array is in direct contact with the lateral wall under the basilar membrane.

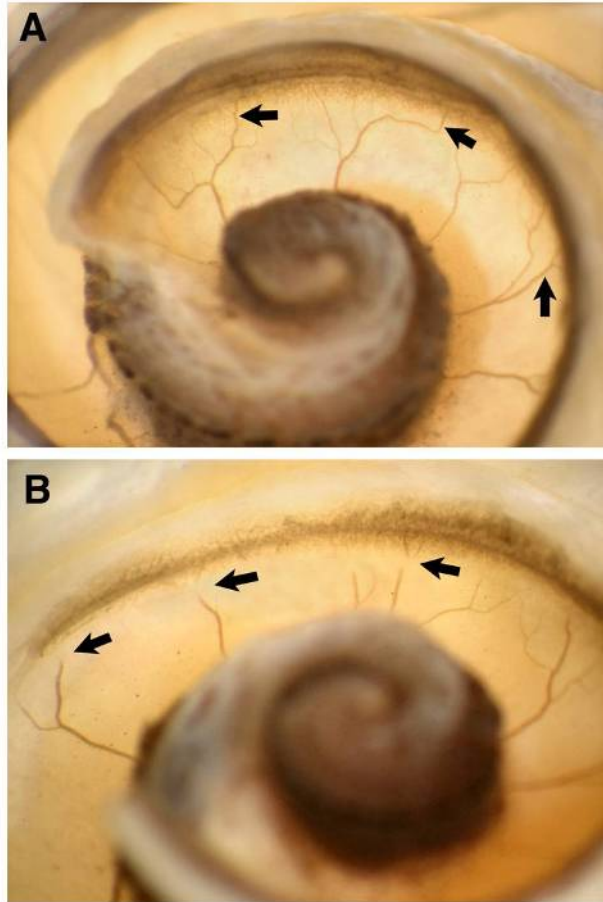
This is a temporal bone which had an implant electrode inserted at the time that the bone was fresh and unfixed. After fixation, osmium staining, and dissection the electrode was removed from scala tympani. "A" shows the apical turn in an area that the electrode did not reach. The arrows indicate normal-appearing venules in the lower part of the spiral ligament. "B" shows an area in the basal turn where the electrode was in contact with the lateral wall immediately below the basilar membrane (see preceding photograph). Close inspection shows that the electrode has compressed the collecting venules and "squeezed" blood from them just below the attachment area of the basilar membrane. Several of the spots of apparent compression are indicated by the arrows.

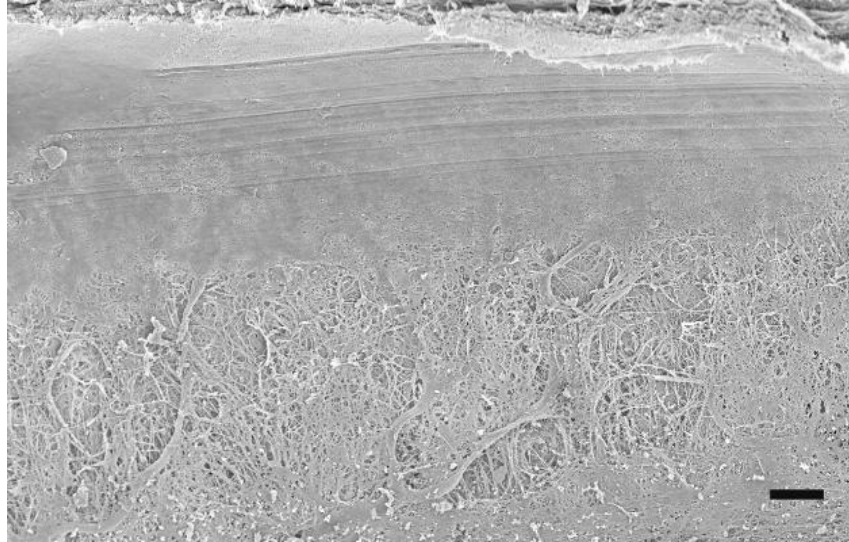
Another preparation in which an electrode array was inserted at the time the temporal bone was fresh and unfixed. After fixation and osmium staining, the array was removed from scala tympani. This SEM image shows the surface of the spiral ligament in an area where the array contacted the lateral wall. In the upper portion of the image the spiral ligament tissue is seen to be compressed and marked by grooves produced by the electrode. Below that area the normal porous surface of the spiral ligament is seen.

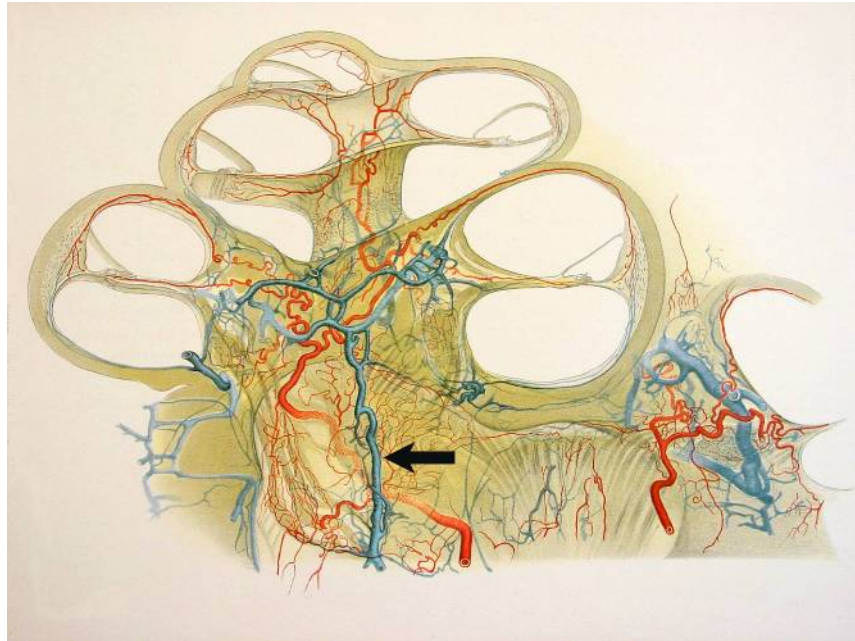
Cochlear vasculature as Illustrated by Siebenmann (1894). The arrow indicates the central auditory vein, which when present, may provide collateral venous drainage for the vessels associated with scala tympani.

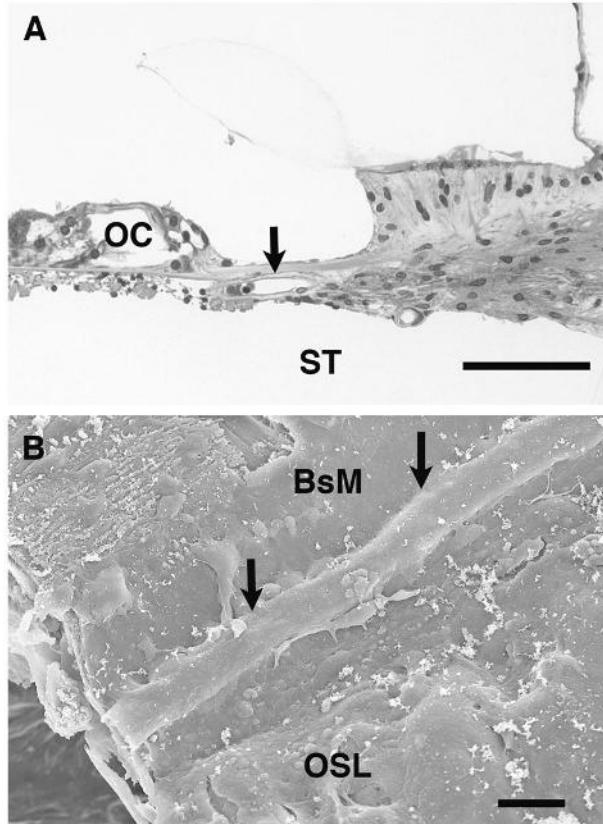
**A:** Cross section showing a vessel (arrow) emerging from the edge of the osseous lamina. OC, organ of Corti; ST, scala tympani.

**B:** Scanning micrograph of the under surface of the basilar membrane (BsM) and osseous lamina (OSL). The arrows indicate the spiral vessel beneath the basilar membrane, which is exposed to the perilymphatic space.

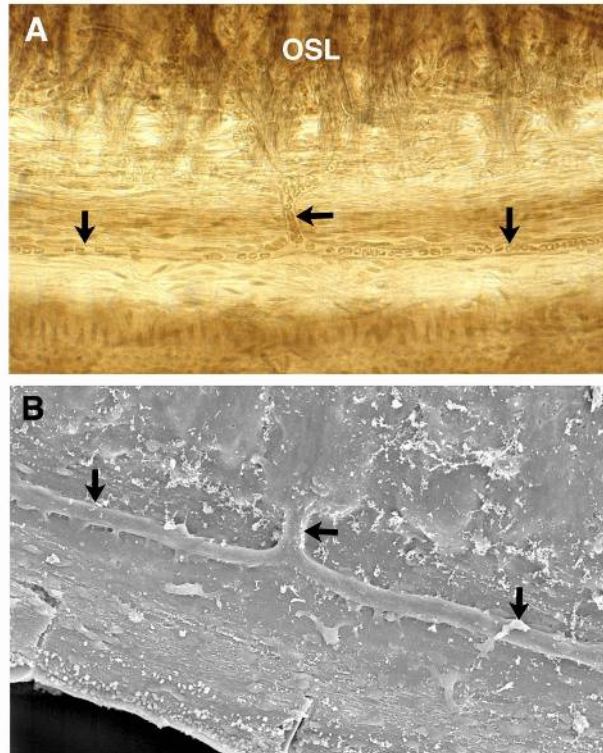
**A:** Whole-mount preparation of osseous lamina (OSL) and basilar membrane at a level of focus that shows a vessel (horizontal arrow) emerging from the OSL and joining the spiral vessel (vertical arrows) under the basilar membrane.

**B:** Scanning micrograph showing a similar situation in which a vessel (horizontal arrow) emerges from the OSL to join the spiral vessel (vertical arrows). As in the preceding micrograph (#32), the spiral vessel under the basilar membrane appears exposed to the perilymphatic space and therefore vulnerable to electrode injury.
