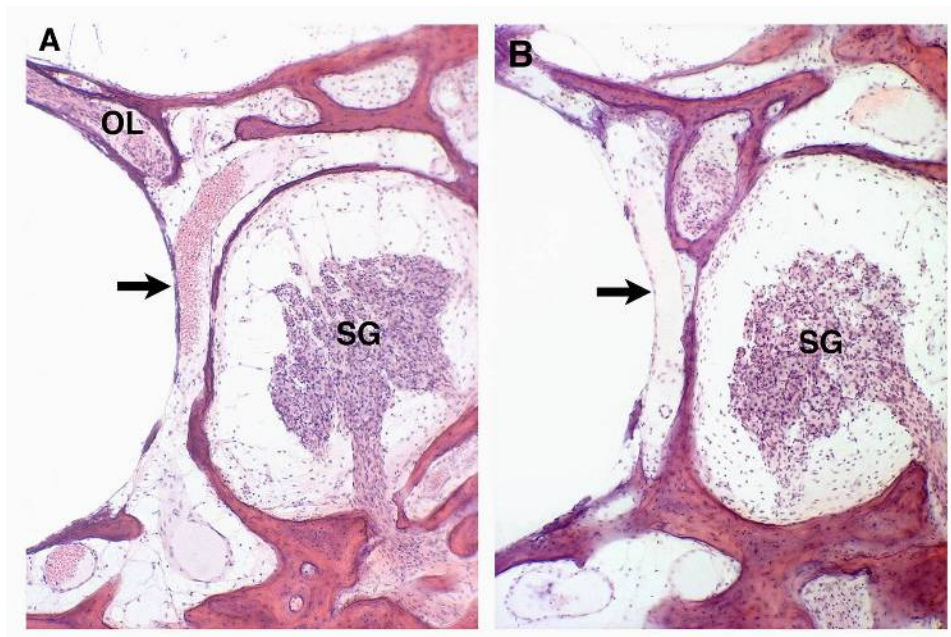
Cross sections of the modiolus region showing veins coursing near the surface of the modiolar wall. In "A" the vein indicated by the arrow has a very thin covering of bone. In an adjacent section, shown in "B" , a similar vein (arrow) appears entirely exposed to the perilymphatic space. (In this case the vein does not contain RBC's, but it certainly does appear to be a vein .) It would seem that such vessels might easily be injured by a perimodiolar electrode. OL, osseous lamina; SG, spiral ganglion. See slide 23 for a view of this anatomy in a dissection.
